**GEOTEXTILE STRIPS
AS A
REFLECTIVE CRACK TREATMENT FOR AC OVER AC**

Experimental Feature
Final Report
OR 88-03

OREGON DEPARTMENT OF TRANSPORTATION
HIGHWAY DIVISION
RESEARCH UNIT
Salem, Oregon 97310

FEBRUARY 1990

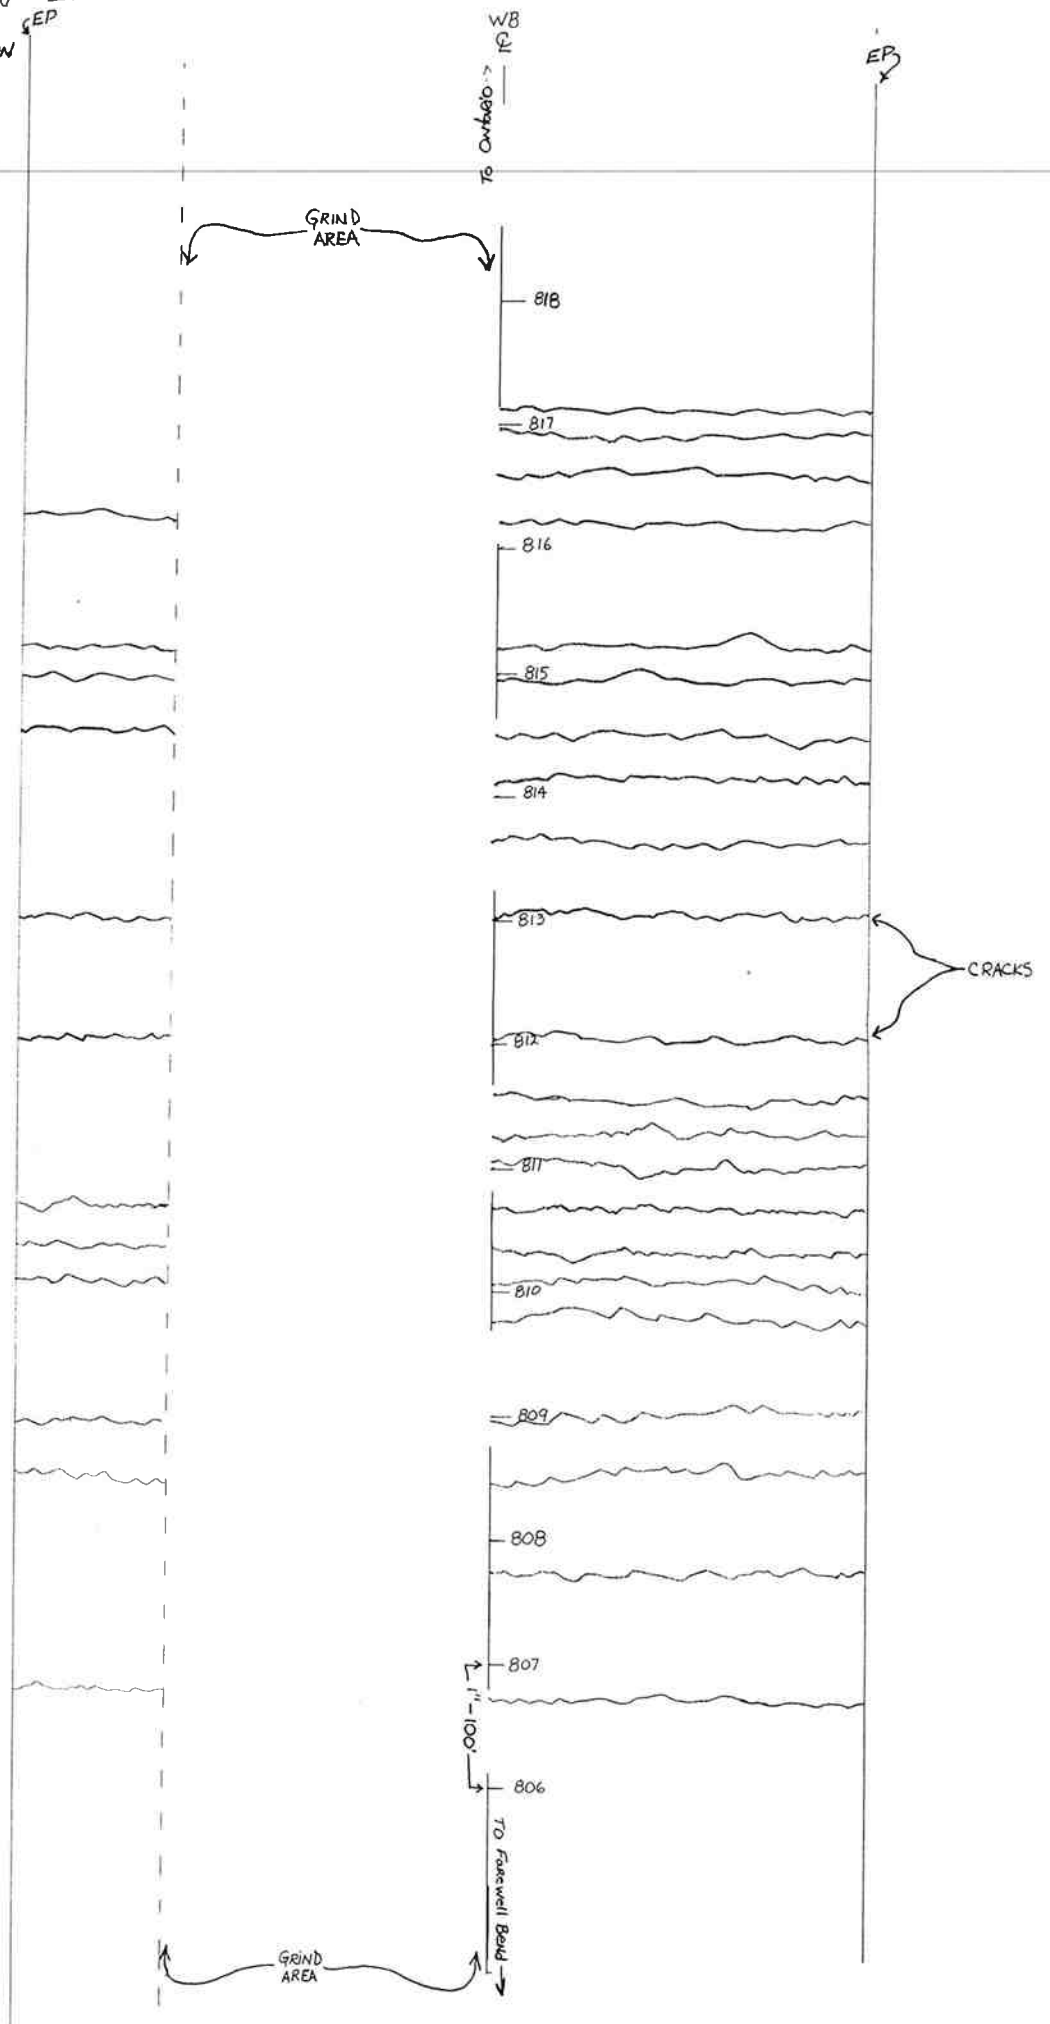
(Figure 1)

Test Section #1
Control Section
(No Geotextile
Placed in this
section.)

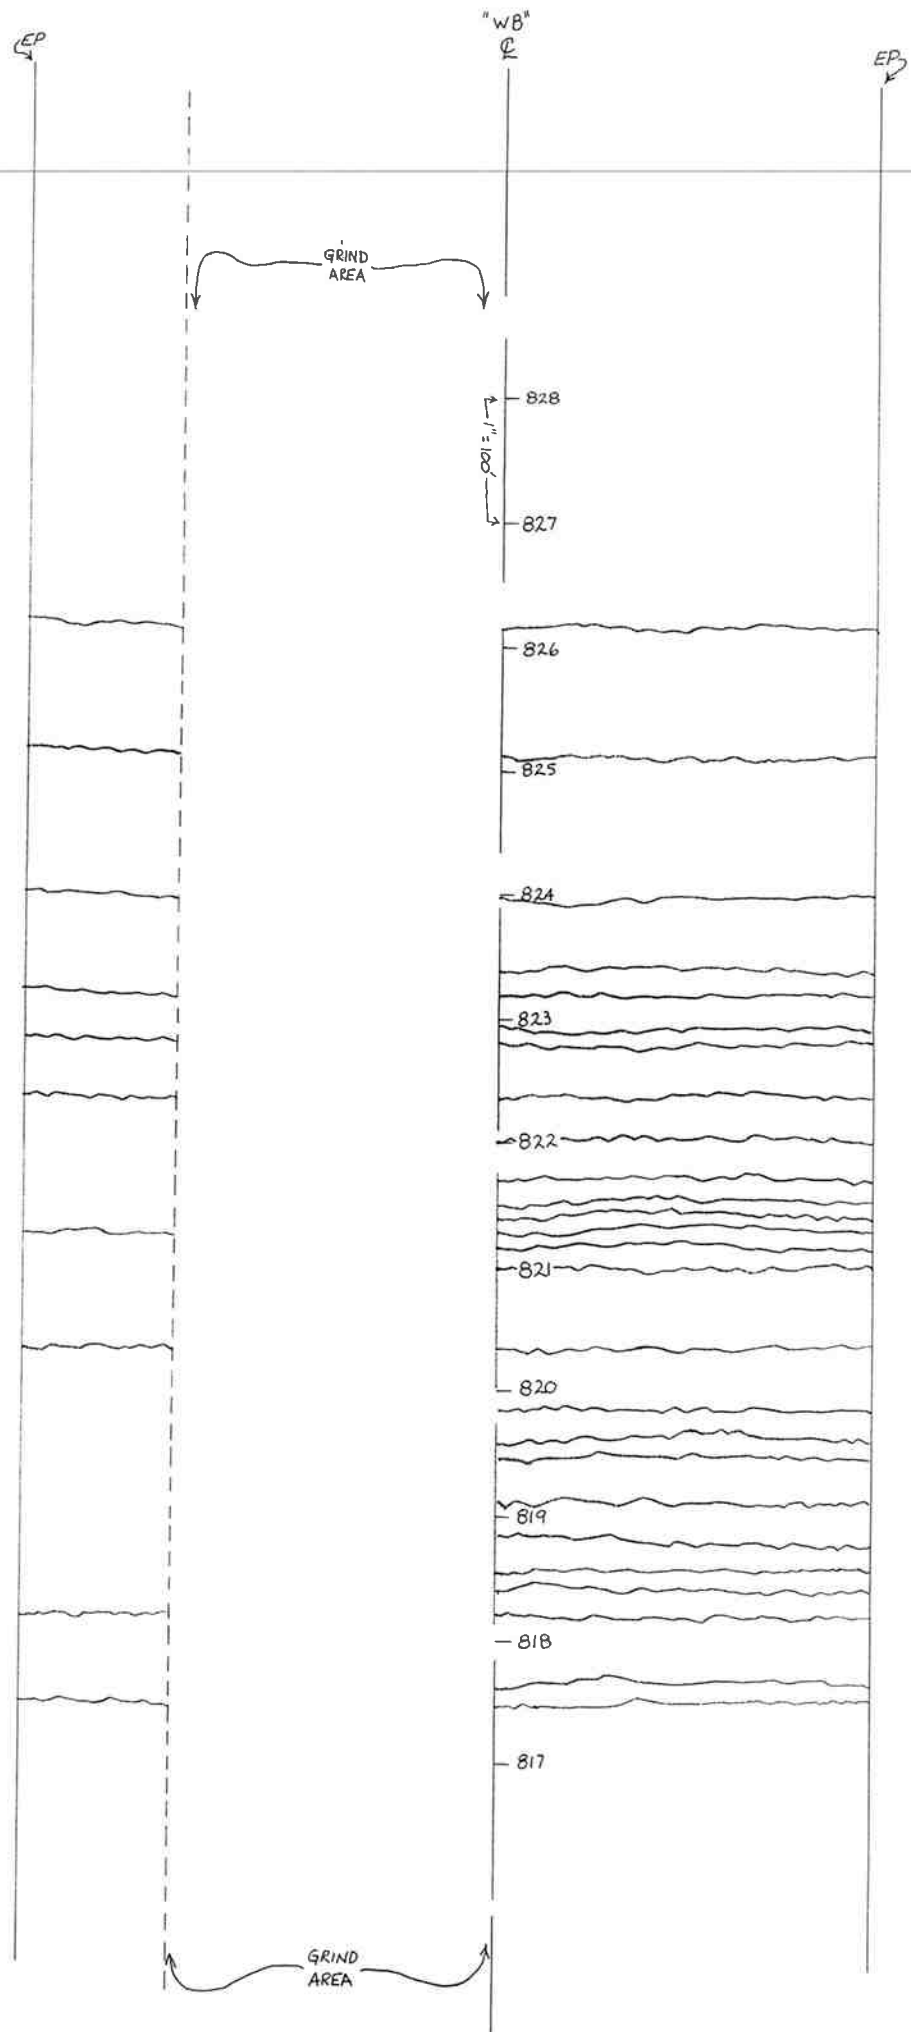
(Figure 2)

Test Section #2
(This section
has Grottertile
Placed over
the cracks.)

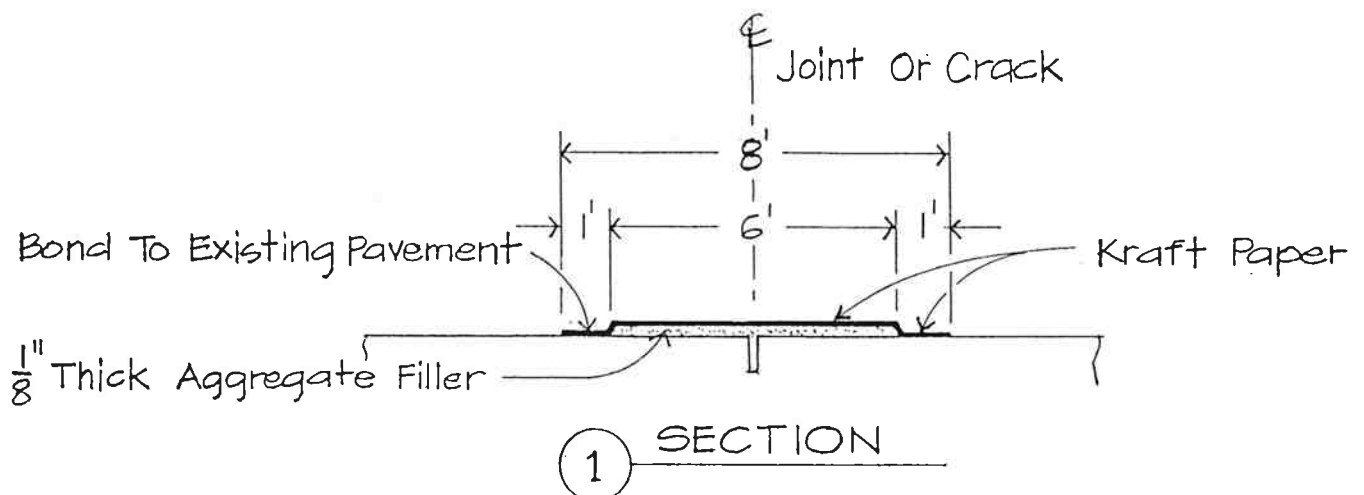
FIGURE 3: BOND BREAKER DETAILS

This project was constructed in three lifts of AC 3", 2", and 1" in thickness in order of placement. It was found that, where the fabrics were placed over a bond breaker, reflective cracking was delayed for at least six years. The fabrics that were placed directly over the PCC pavement without bond breakers did not appear to perform better than the control sections without fabrics. There appeared to be some benefit from fabrics alone when placed between the first and second lifts.
